Using pre-planted pallets to stabilise an area of nutrient rich silt at Cockshoot Broad, Norfolk, England

Kelly A. & Southwood R.R.

The Broads Authority, 18 Colegate, Norwich, Norfolk NR3 1BQ, UK

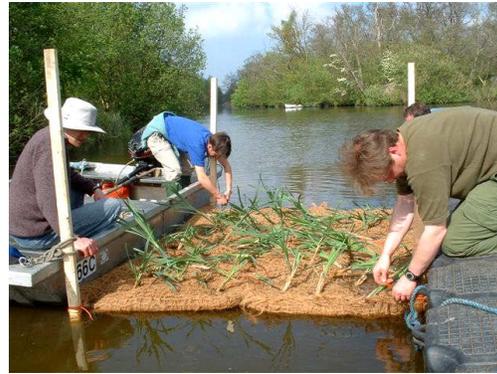
Figure 1. Installation of a coir pallet and planting of bulrush *Schoenoplectus lacustris* and reedmace *Typha latifolia*.

As a trial, three 4 x 4 m areas of coir pallets were pre-planted with either reed *Phragmites australis* and greater reedmace *Typha latifolia*, or bulrush *Schoenoplectus lacustris* and lesser reedmace *Typha angustifolia*. The pallets were then suspended just under the surface of the water from four posts driven into the mud (Fig. 1). The entire structure was enclosed with chicken wire to prevent birds e.g. geese *Anser* spp., grazing and trampling the vegetation (Fig. 2). Once the plants grew to the top of the enclosure, the wire on the top was removed (Fig. 3).

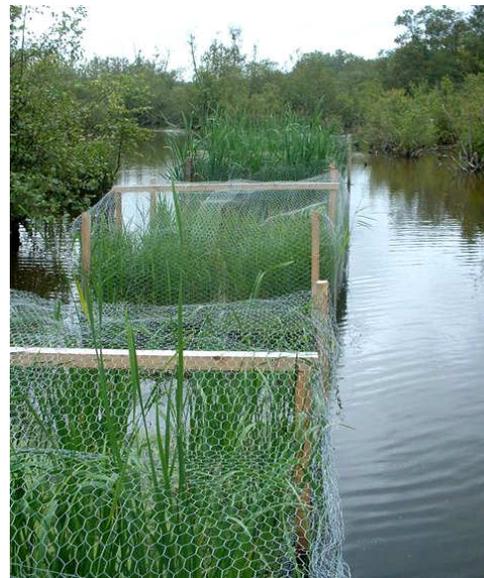
Figure 2. Growth of bulrush *Schoenoplectus lacustris* and reedmace *Typha latifolia* after 3 weeks.

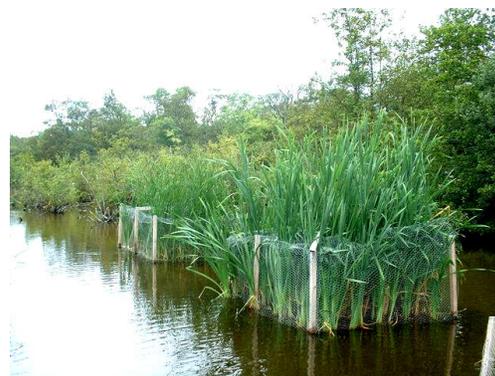
Figure 3. Growth of bulrush *Schoenoplectus lacustris* and reedmace *Typha latifolia* after 3 months. The wire mesh on the top of the enclosure had been removed.
